Doan Brook Enhancement Project

Conceptual Design and Implementation Schedule

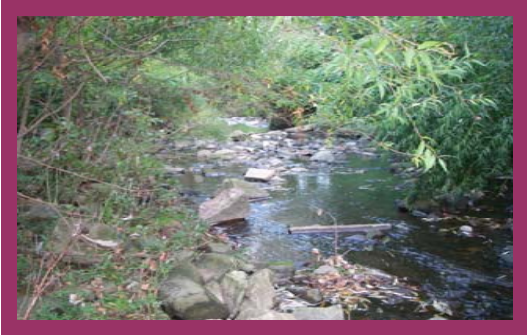
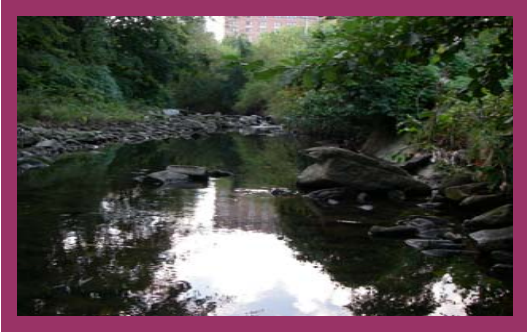
A small section of the brook just downstream of the UC culvert has been restored and appears to be stable. Downstream, the channel has over widened and has very limited natural stream and habitat features, such as a stable pool and riffle complex. A steep bank along the east side is eroding. Sections of contributing walls remain that are in relatively good condition and the remaining banks are in fair condition.

Previous Restoration Effort ▼

It appears that the previously restored section has identified a stable cross section they could potentially be carried downstream. The steep slope behind the Museum of Art will need to be stabilized and re-vegetated. It appears that the new channel and some floodplain relief can be confined within the contributing rock walls that are still intact downstream. Stable pools and riffles, as well as native vegetation along the riparian area should provide suitable habitat for an improved biotic community.

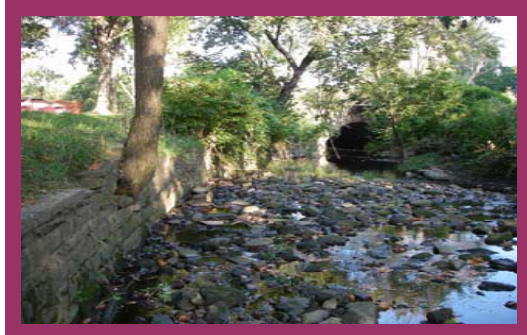
Existing Wall ▼

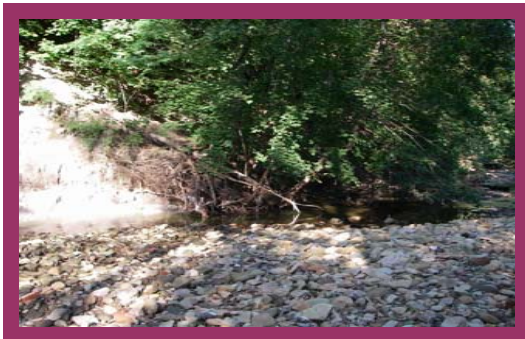
The section immediately downstream of the East 105th Street culvert is bound by a sheet pile wall that serves as the right bank for approximately 100'. Downstream, the channel has over-widened and has very limited natural stream and habitat features, such as a stable pool and riffle complex. A steep bank along the west is eroding. Most of the contributing walls through this reach are either completely missing, are severely degraded, or have been replaced with poured concrete.

Eroding Bank ▼

The sheet pile section just downstream of the E. 105th Street culvert is doing a good job holding the bank together and probably should be left in place. The steep slope just downstream will need to be stabilized and re-vegetated.

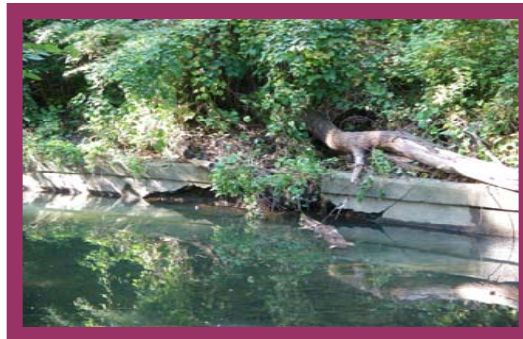
Failed Concrete Wall ▼

The steep slope to the west limits the lateral movement of the stream channel in this direction. The degrading rock walls have forced the stream in the opposite direction in several spots, which has accelerated the bank erosion. Although the stream is over-widened through this reach, the pond and park setting limit the amount of floodplain relief that can be built back into the system.

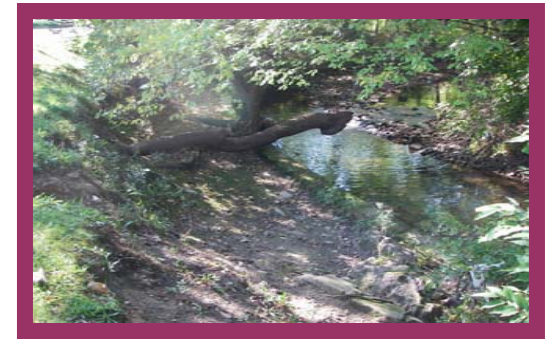
Missing Wall ▼

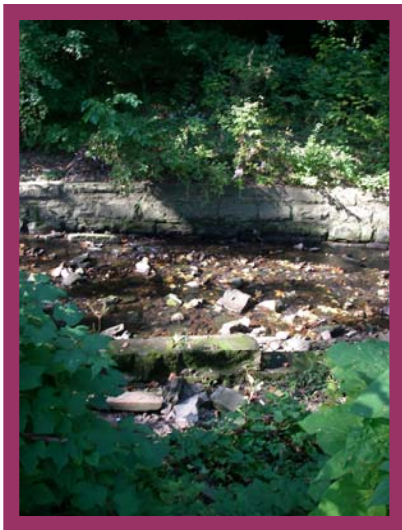
Leaning Wall with Undermined Base ◀

Sections of contributing walls that are still in good shape could potentially be left in place on outside meanders to provide bank stability.

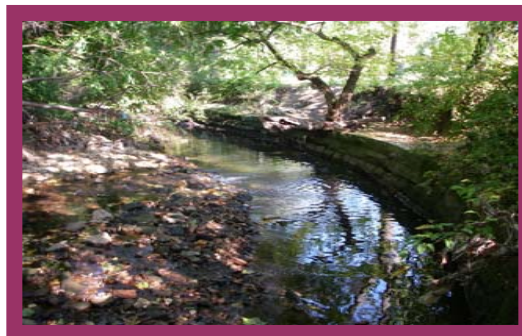
Most of the contributing walls through this reach are either completely missing, are severely degraded, or have been replaced with poured concrete.

Missing Wall on Left Bank ▼

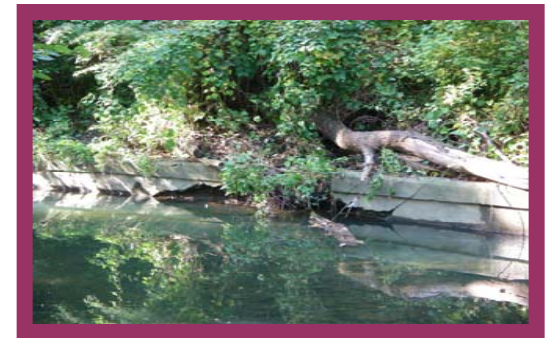
Failed Concrete Wall ▼

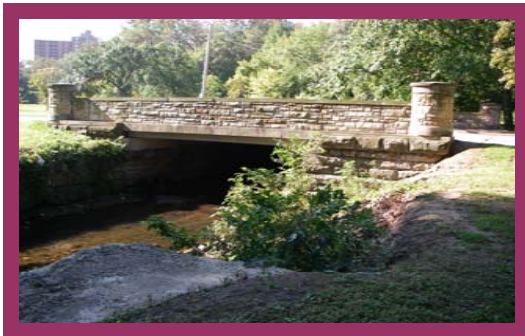
Eroding Bank ▼

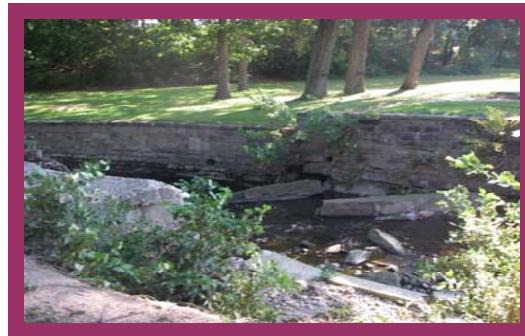
There is a small section of wall that is missing just downstream of the MLK Boulevard culvert.

Failed Wall ▼

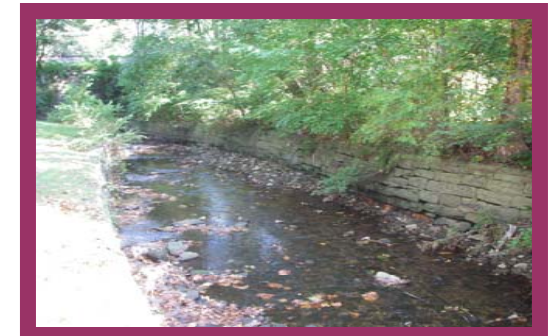
Reach 4 begins at the downstream end of the MLK Boulevard culvert and ends at the upstream end of the Wade park Boulevard culvert. This reach is approximately 550' and is the first reach within the project area where most of the contributing walls are in good condition.

Existing Wall ▼

During the assessment phase of this restoration project, the idea of building habitat between the contributing stone walls was discussed for portions of Doan Brook. This section would be a good site for keeping the contributing walls in place, up to bankfull elevation, and reconstructing the walls further back on the banks to create a wider floodplain bench.

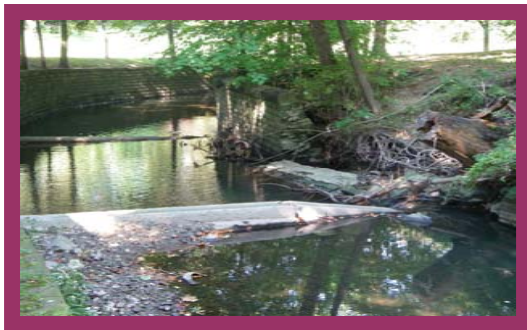
The large meander bend at the start of the project area is very close to the all purpose path running along MLK Boulevard.

Eroding Bank ▼

There is room along the large meander bend to pull back the stream to the east and create a vegetated point bar. There is a small section of contributing wall through this meander that will need to be repaired, but the wall might be able to be left in place to provide bank stability and protection to MLK Boulevard. A pool / riffle system or "B" Type channel might be suitable for this reach, which might be a more natural replacement for the check dams.

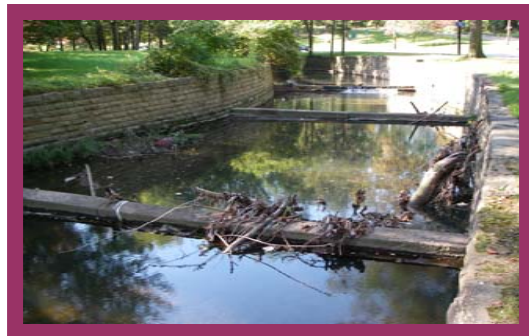
There are nine concrete check dams through this reach that most likely were installed as some form of grade control. The check dams have created pockets of stagnant water and areas of heavy bed load accumulation.

Concrete Check Dams ▼

The primary goals for Reach 5 will be to remove the nine check dams and reconstruct a stable stream channel with the proper dimension, pattern, and profile that makes up for the loss of the check dams.

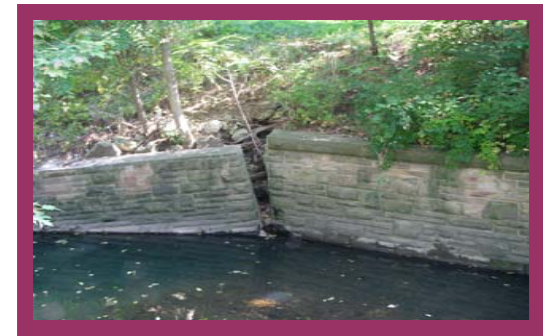
Some of the contributing walls through this reach are severely degraded, but there are still sections that are in good condition.

Failed Wall ▼
