# Watershed Advisory Committee

CUYAHOGA RIVER SOUTH | OCTOBER 14, 2021

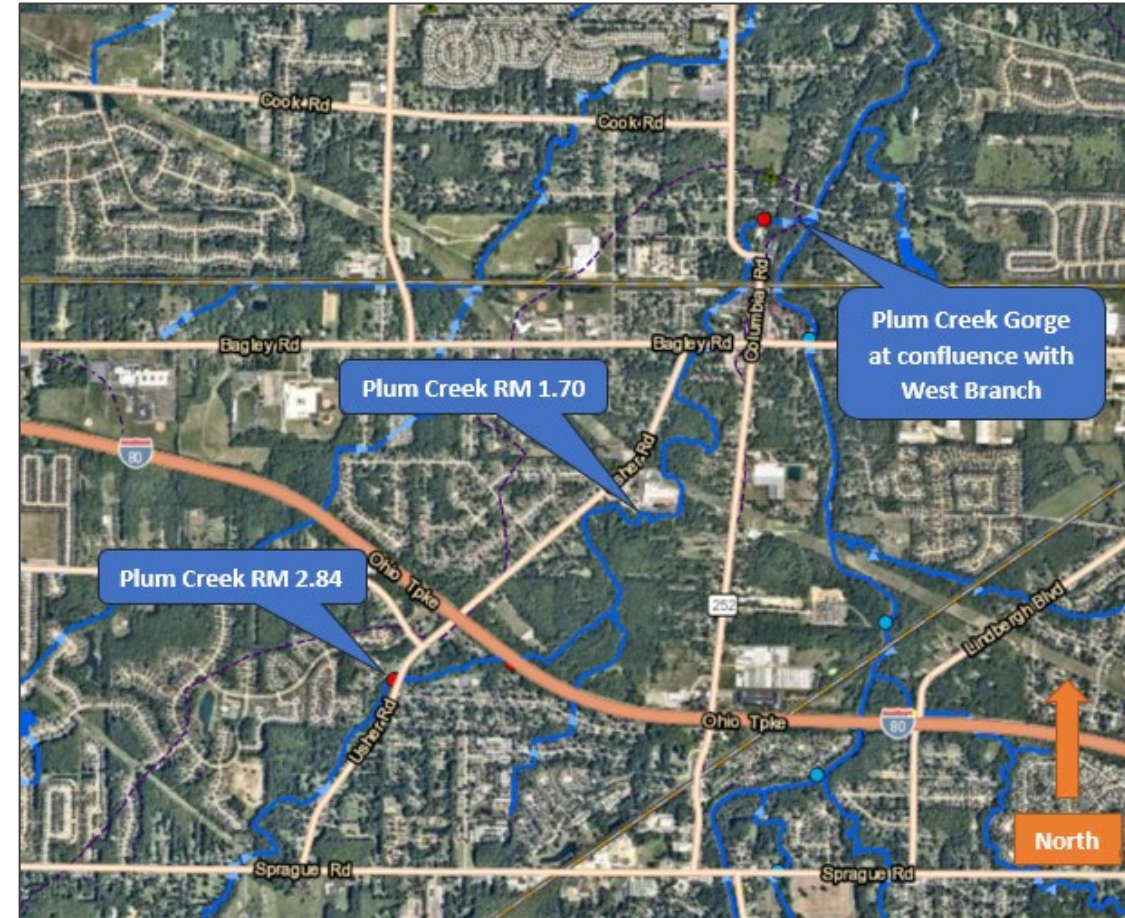
**Plum Creek seed/translocation locations**

- All source locations within the Rocky River watershed
- Goal: minimum of 200 fish/species/year into Plum Creek at two seed locations
- Minimum of 3 consecutive years of translocation
  - Reduces environmental variability of a bad spawning/weather year
  - Increases genetic diversity
  - Increases number of fish introduced and chance of success
- Translocate in the spring before fish spawn
- Tag every fish with a visual implant elastomer
- Perform a fall sampling to determine survivability

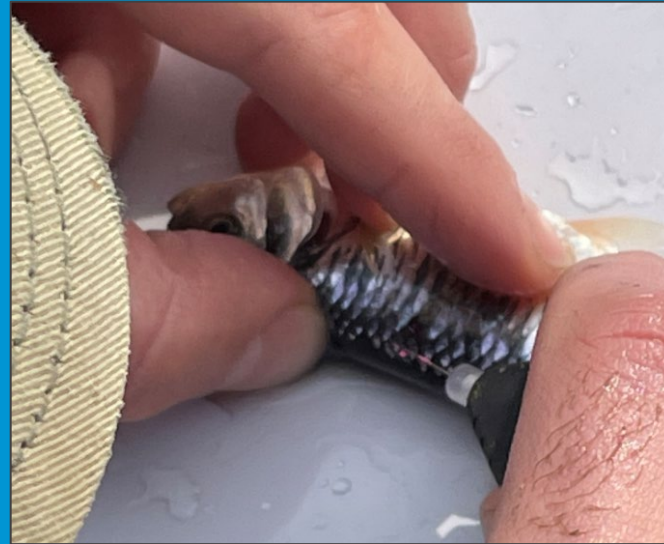
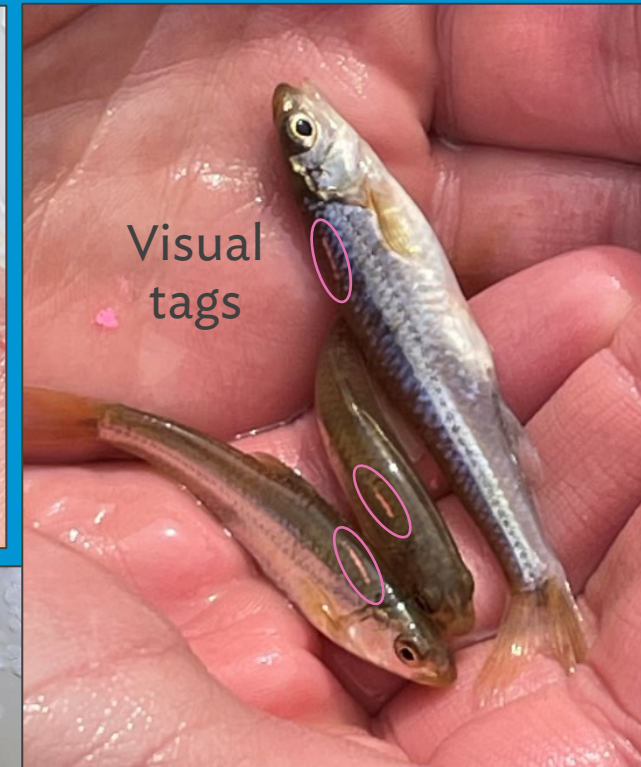
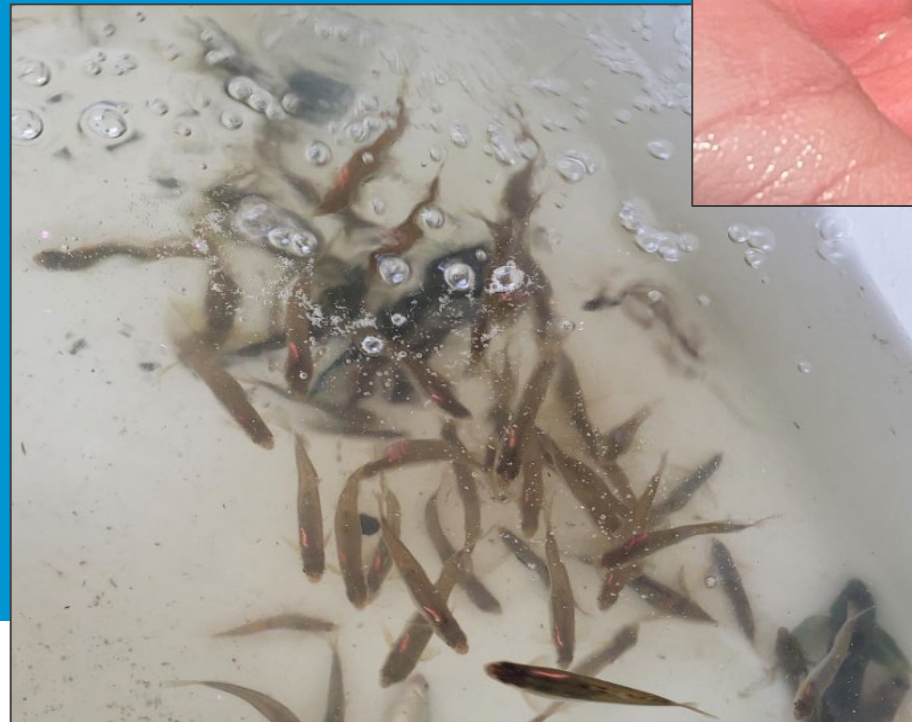
- Tagging fish benefits:
  - Color coded by year
    - Determine long-term or multi-year survivability success
  - Determine recruitment (successful spawn) immediately upon fall sampling of Plum Creek
  - Document movement throughout the stream

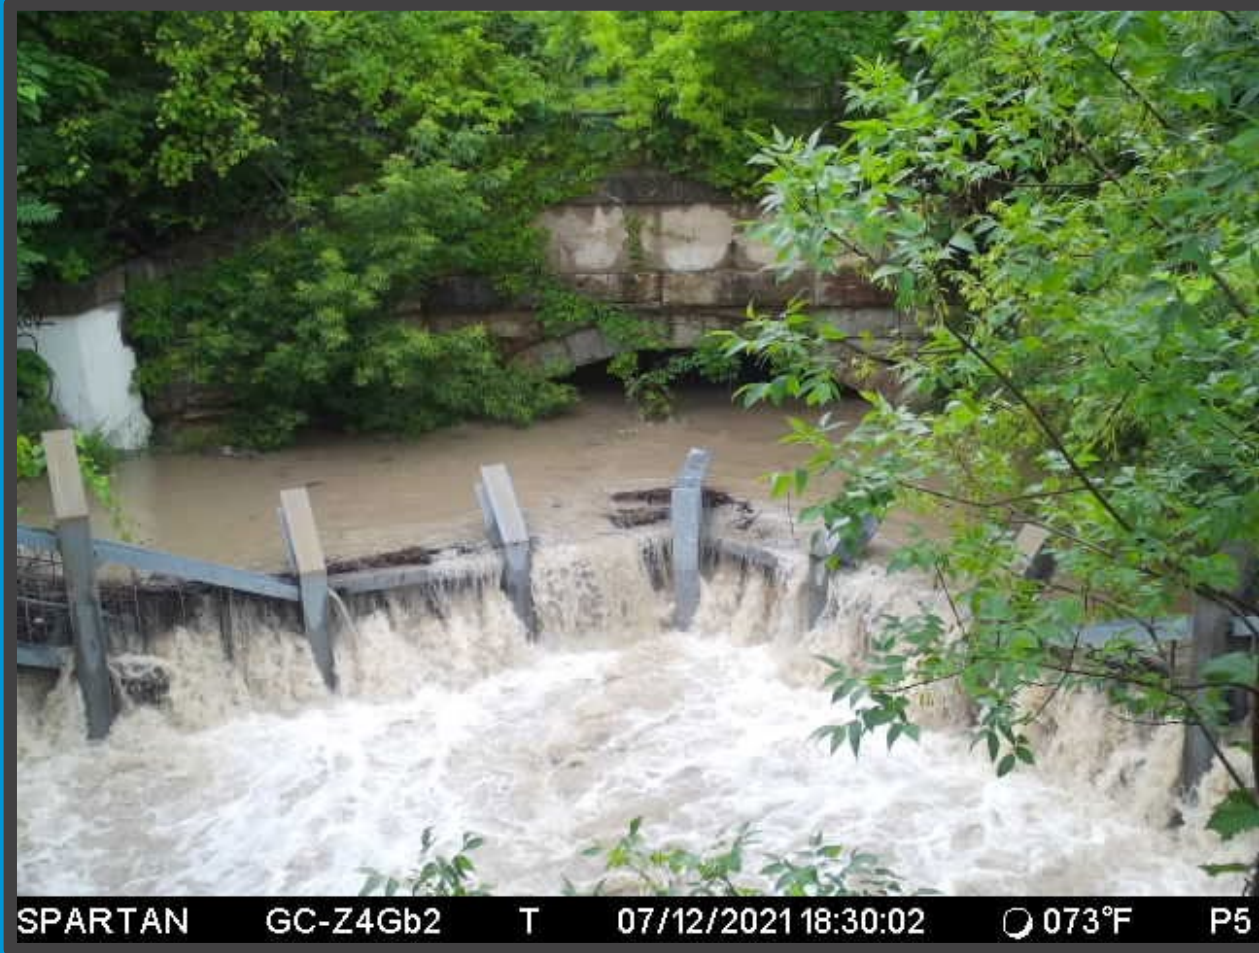
## Airport Debris Rack

# Trail Cams are Reviewed to Identify Potential Stormwater Issues for Field Response

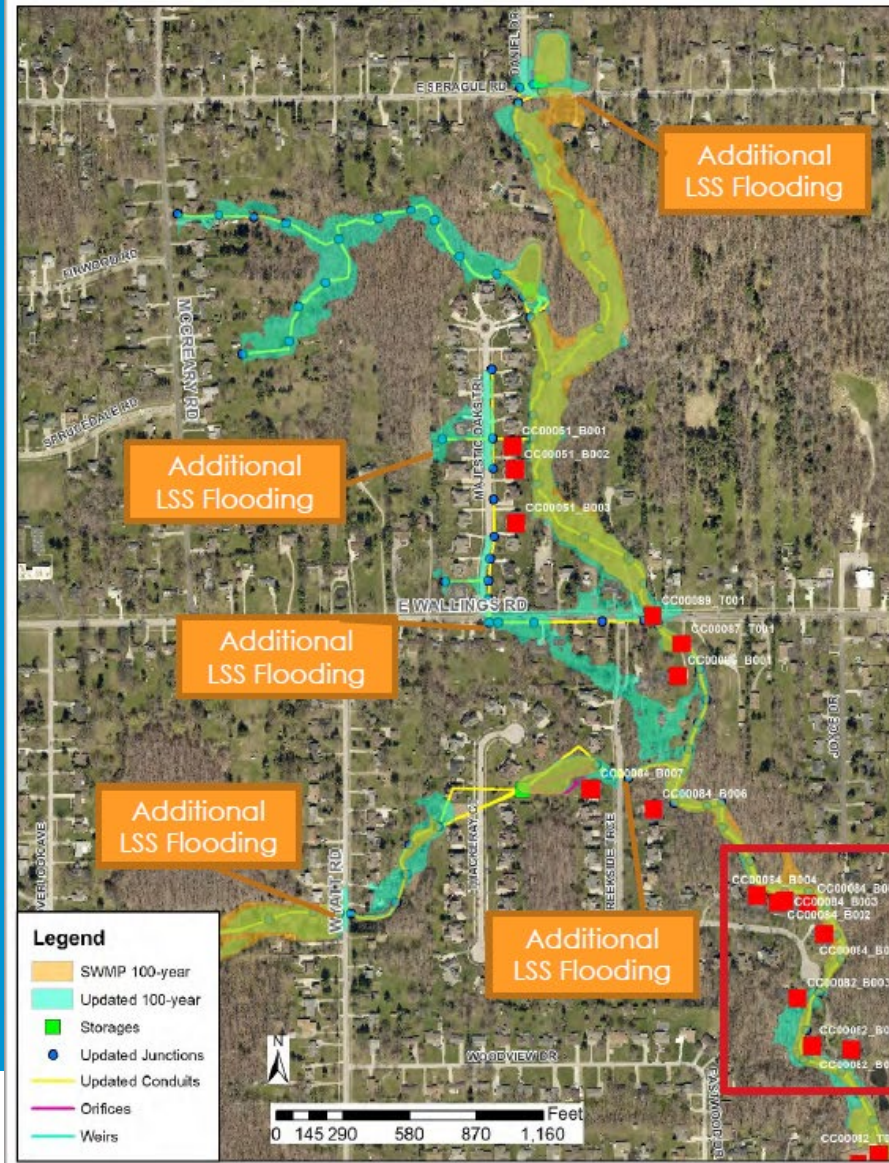
## Problem Definition: Inundation

Questions on detention basin influence on RSS & street flooding not captured in SWMP

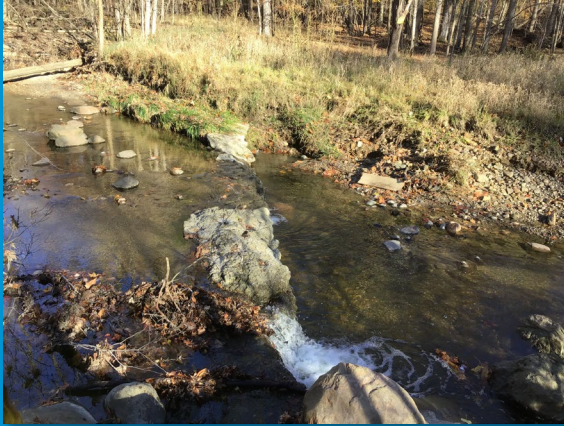
Concrete encased  
18" sanitary line US  
of manhole

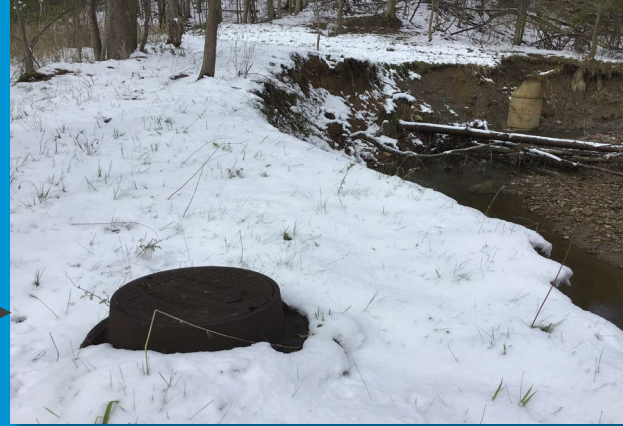
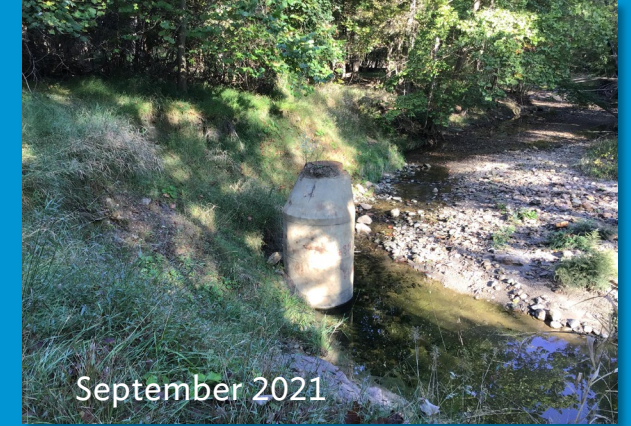
8" sanitary line  
from Treetop Trail  
Dr. DS of manhole  
riser is manhole 4'  
from TOB

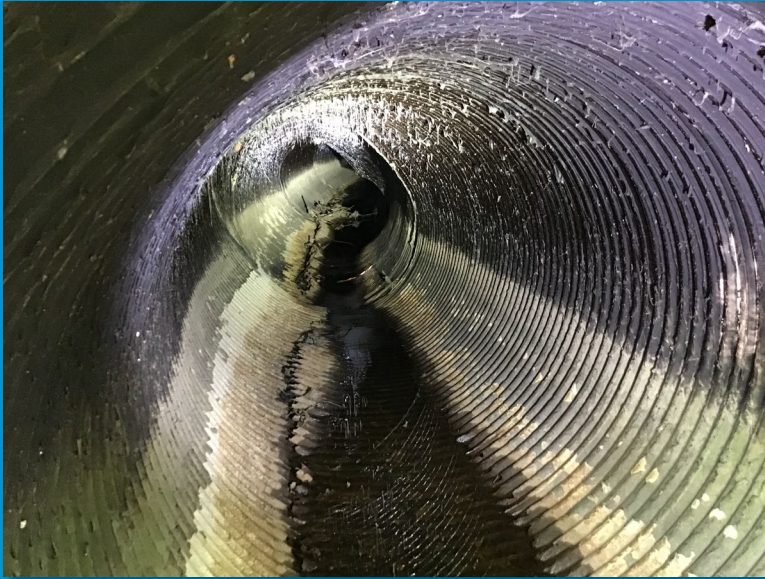
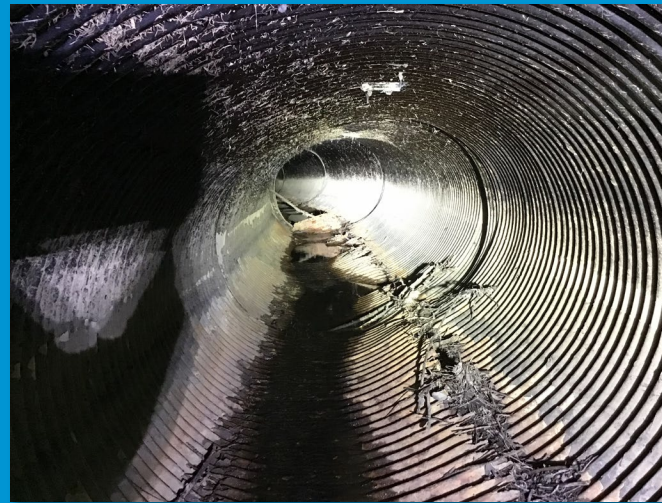
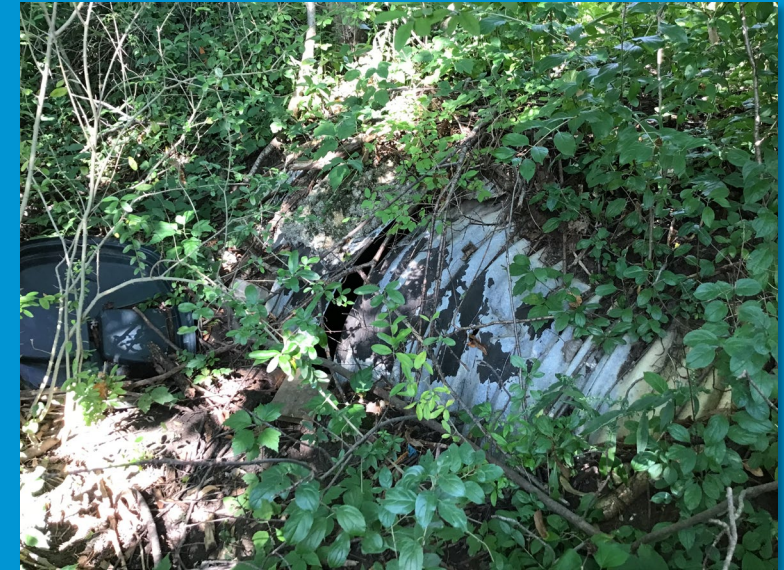
Bear Creek, North Randall

CMP pipe has large rips in the invert and a large deflection. Exposed CMP above the culvert and joint separations visible

Culvert is scheduled to be replaced with a concrete pipe, currently preparing to advertise for construction

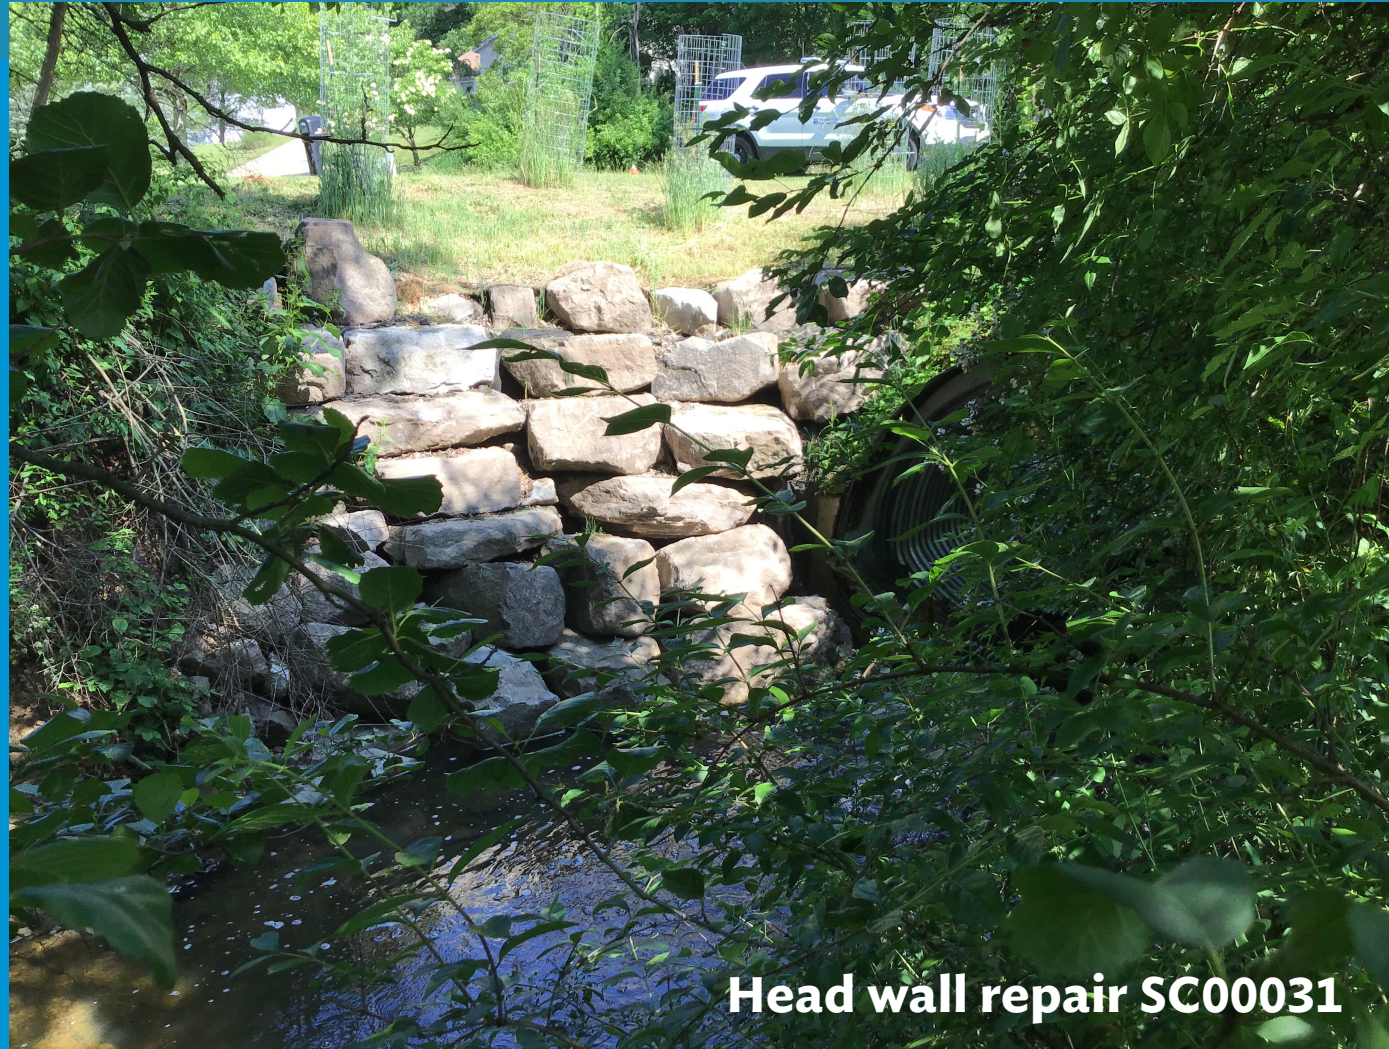
**Head wall repair SC00031**

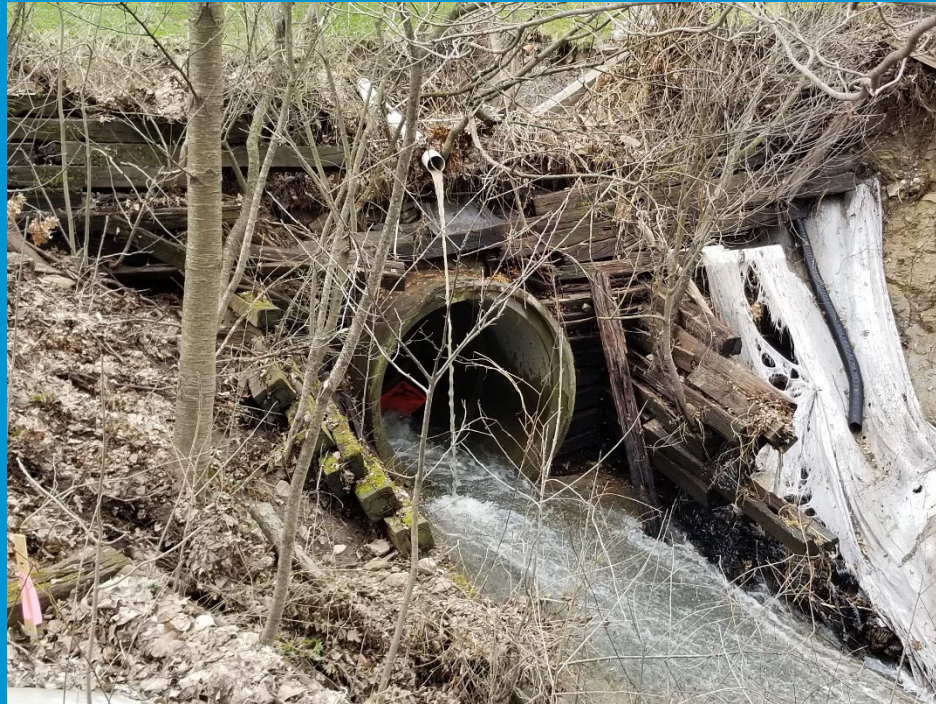
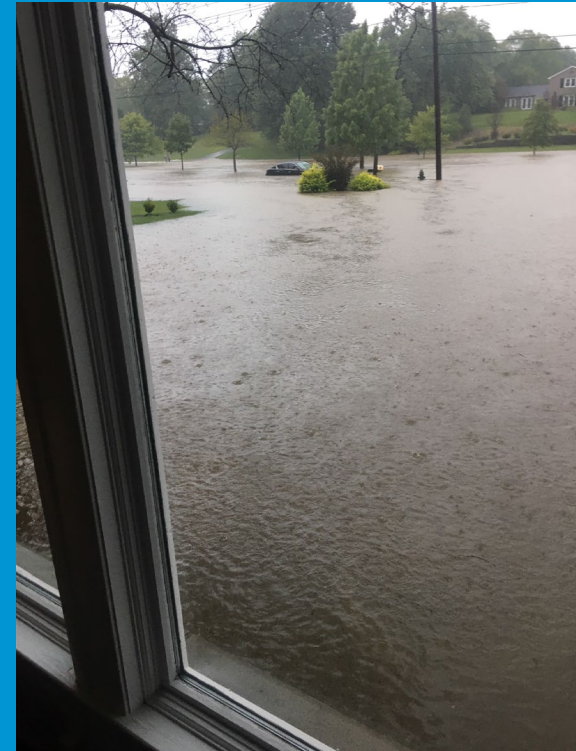
# Pepper Luce Creek Culvert Replacement & Rehabilitation at Gates Mills Boulevard City of Pepper Pike

- Rehabilitate and replace failing culverts
- Enlarge a detention basin to reduce flood risks to Gates Mills Blvd

- City of Pepper Pike is utilizing Community Cost Share for the rehabilitation of the upstream culvert

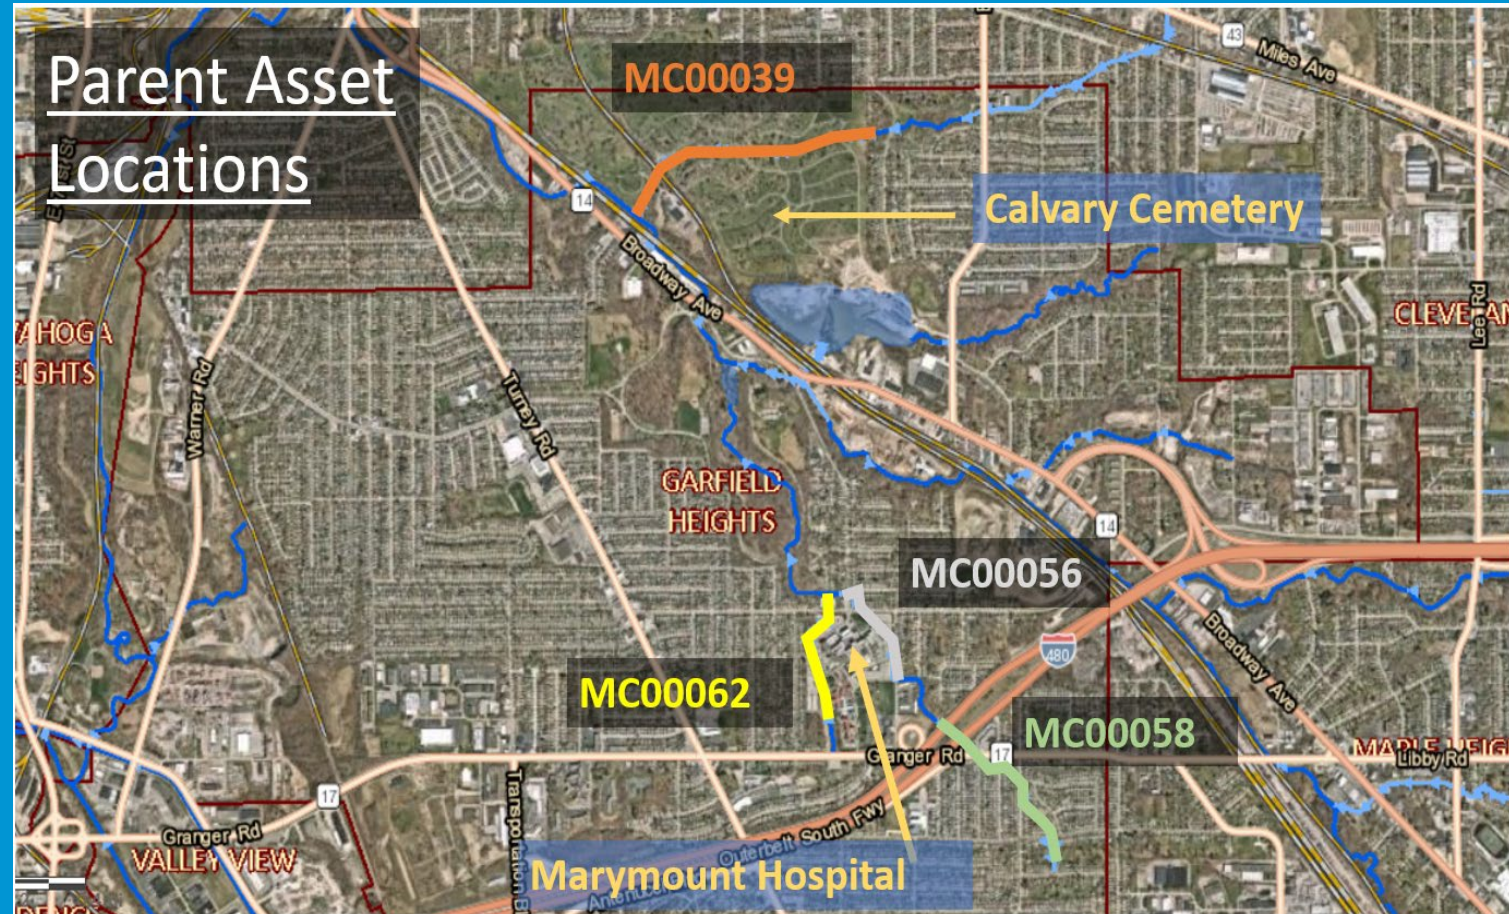
# Mill Creek Culverted Streams Rehabilitation City of Garfield Heights

- Rehabilitate several culverted stream assets in the Mill Creek Subwatershed

- Daylighting alternative of MC00058 to be evaluated as alternative

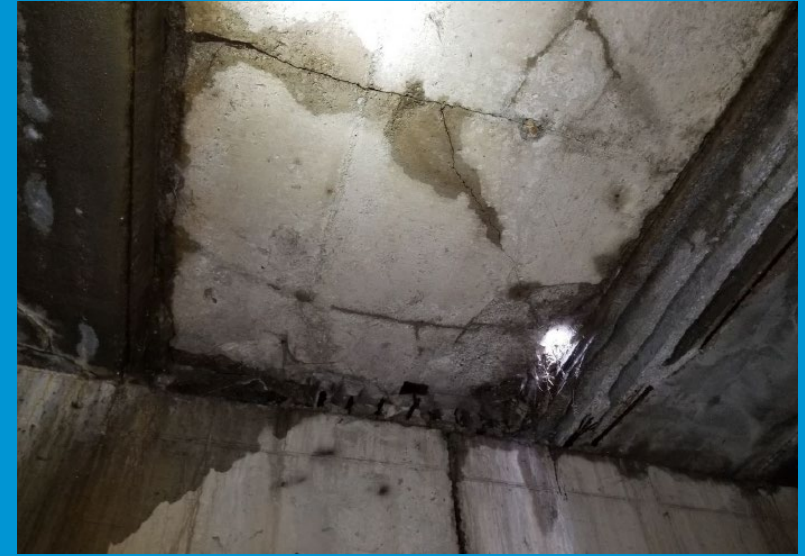
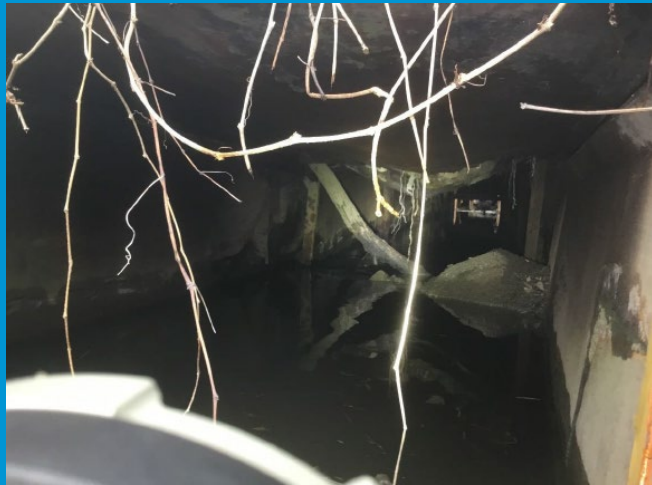
# Culverted Streams Rehabilitation District-wide

- Rehabilitate/replace culverted streams to reduce risk of failure
- Daylight streams currently in culverts, if feasible, to open streams to floodplains and increase water quality
- **Budget ~\$1.5M annually for rehab of these assets**

A	B	C	D	
1	Rank	Asset	Material	SWIM Score	Notes
2	1	WB00084	CMP	4	Under the junkyard. Very poor condition. Milligan neigh
3	2	WB00173	RCP	5	Kollieda Ditch. Failure at the crown. Rest of pipe is "fair"
4	3	HC00053	CMP	4	Potential impact to Brecksville Road. Transitions to CMP
5	4	CH00175	CMP/RCP	5	Concrete has full depth spalling in the box. CMP with tot
6	5	BK00520	CMP	4	Compressed with open joint. Invert loss. Driveways imp
7	6	BD00296	CMP	4	Worse condition than BK00520 but in backyards. Not un
8	7	DE00015	CMP/RCP	4	Concrete with large voids in the invert. Past history of fai
9	8	PC00226	CMP/RCP	4	DS of Ursuline College. Ripped invert at the inlet. Perform
10	9	EW00145	CMP	4	Invert with perforations. Previously lined. Potential impa
11	10	BC00037	CMP/RCP	4	Under multiple businesses. RCP with spalling and expose
12	11	DE00017	RCP	4	Holes in the concrete invert, missing brick, infiltration ru
13	12	DW00091	RCP	4	Sagging crown. Under driveway/local roadway.

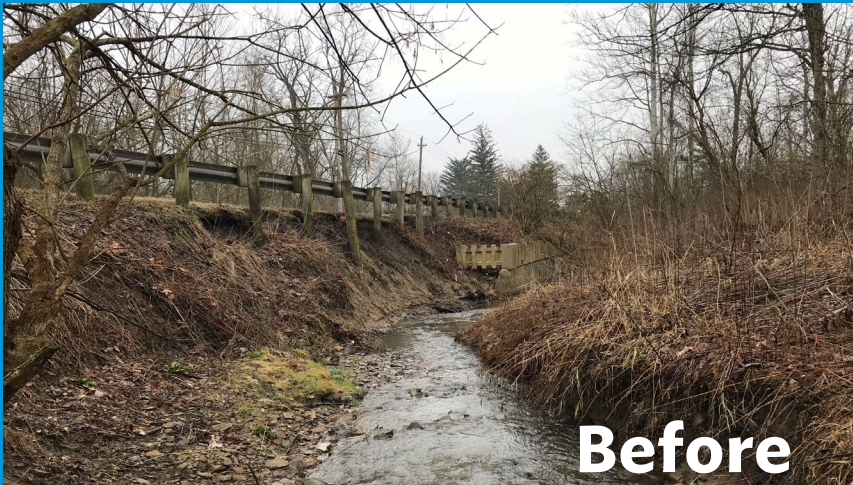
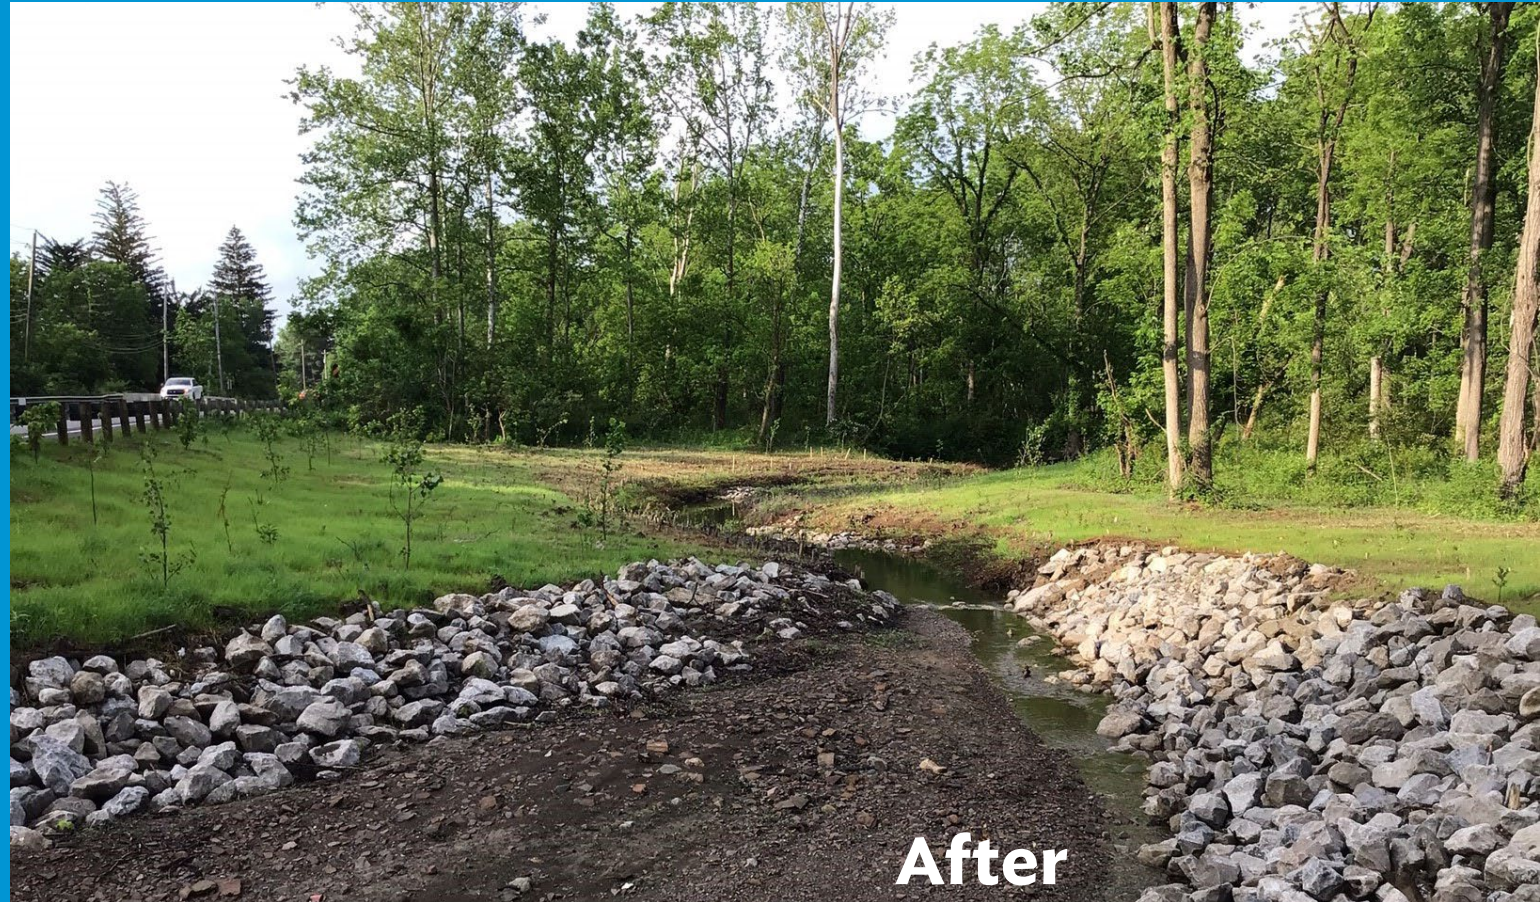
# Rocky River Tributary Stabilization and Re-Alignment Along Ridge Road in City of North Royalton

**Lineal Feet of Stream Work:** 323'

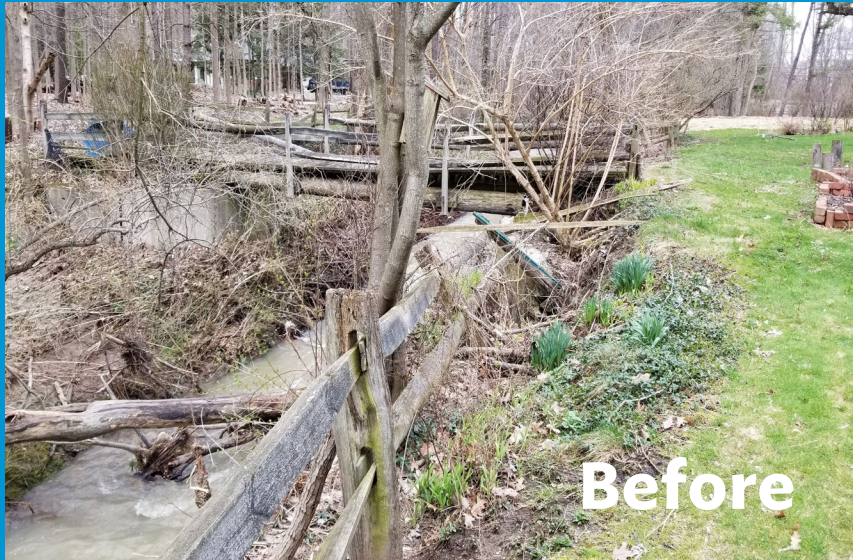
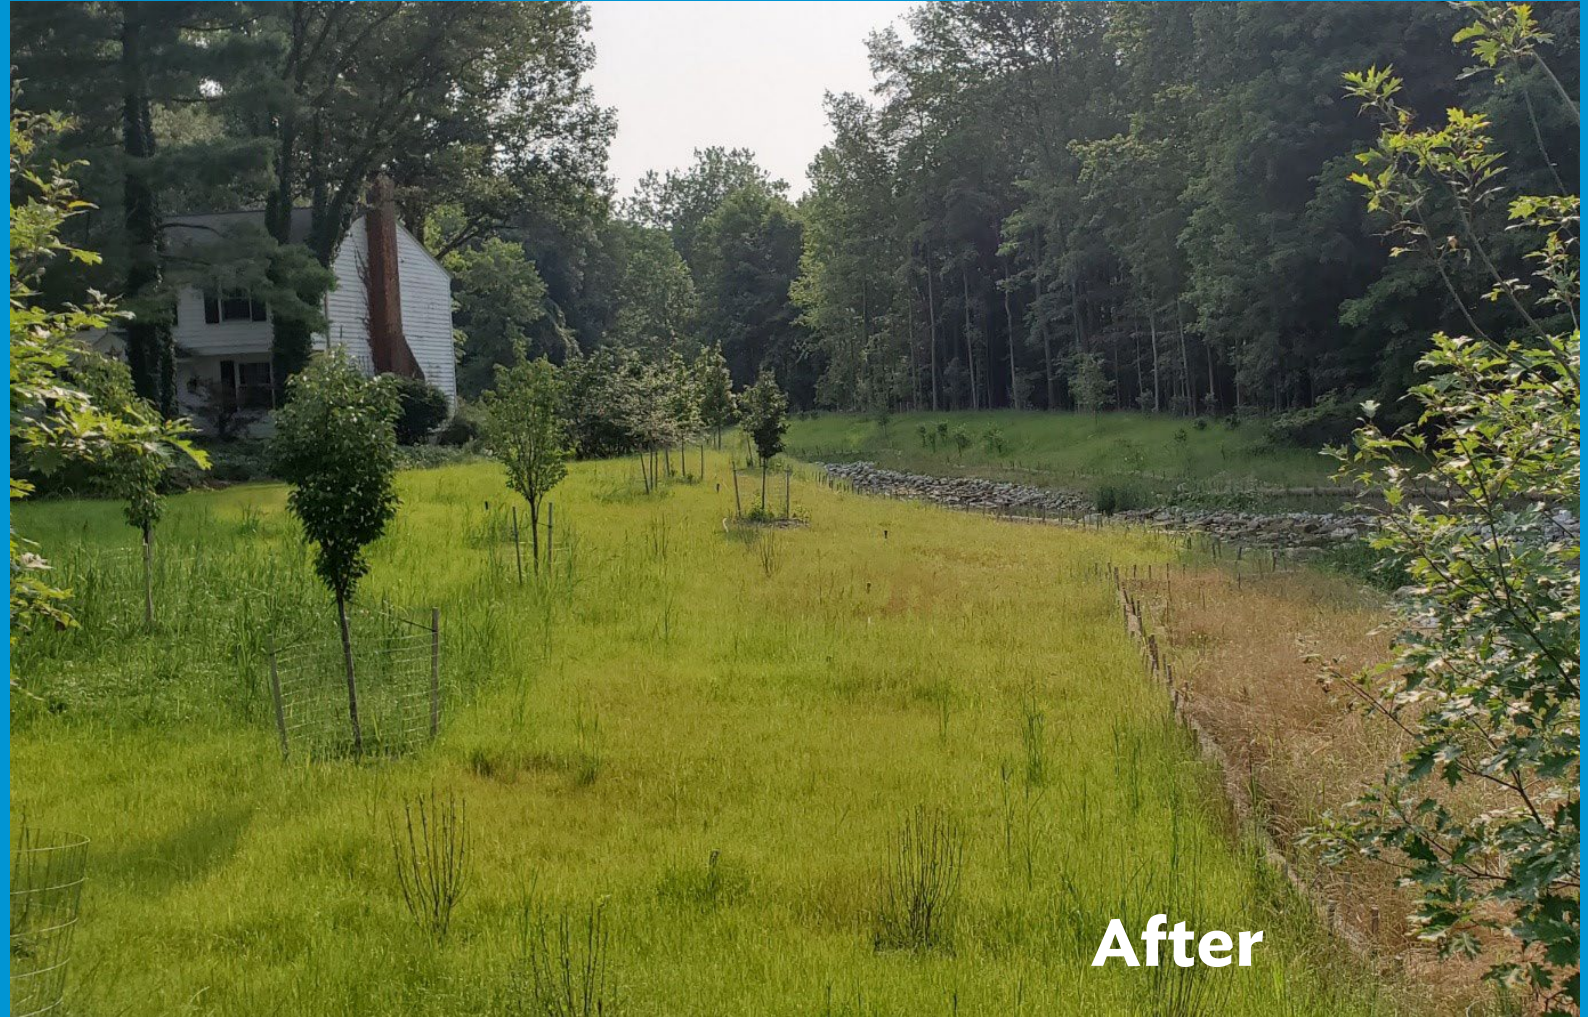
# Pepper Luce Creek Stabilization Near Lander Road

**Lineal Feet of Stream Work:** 575'

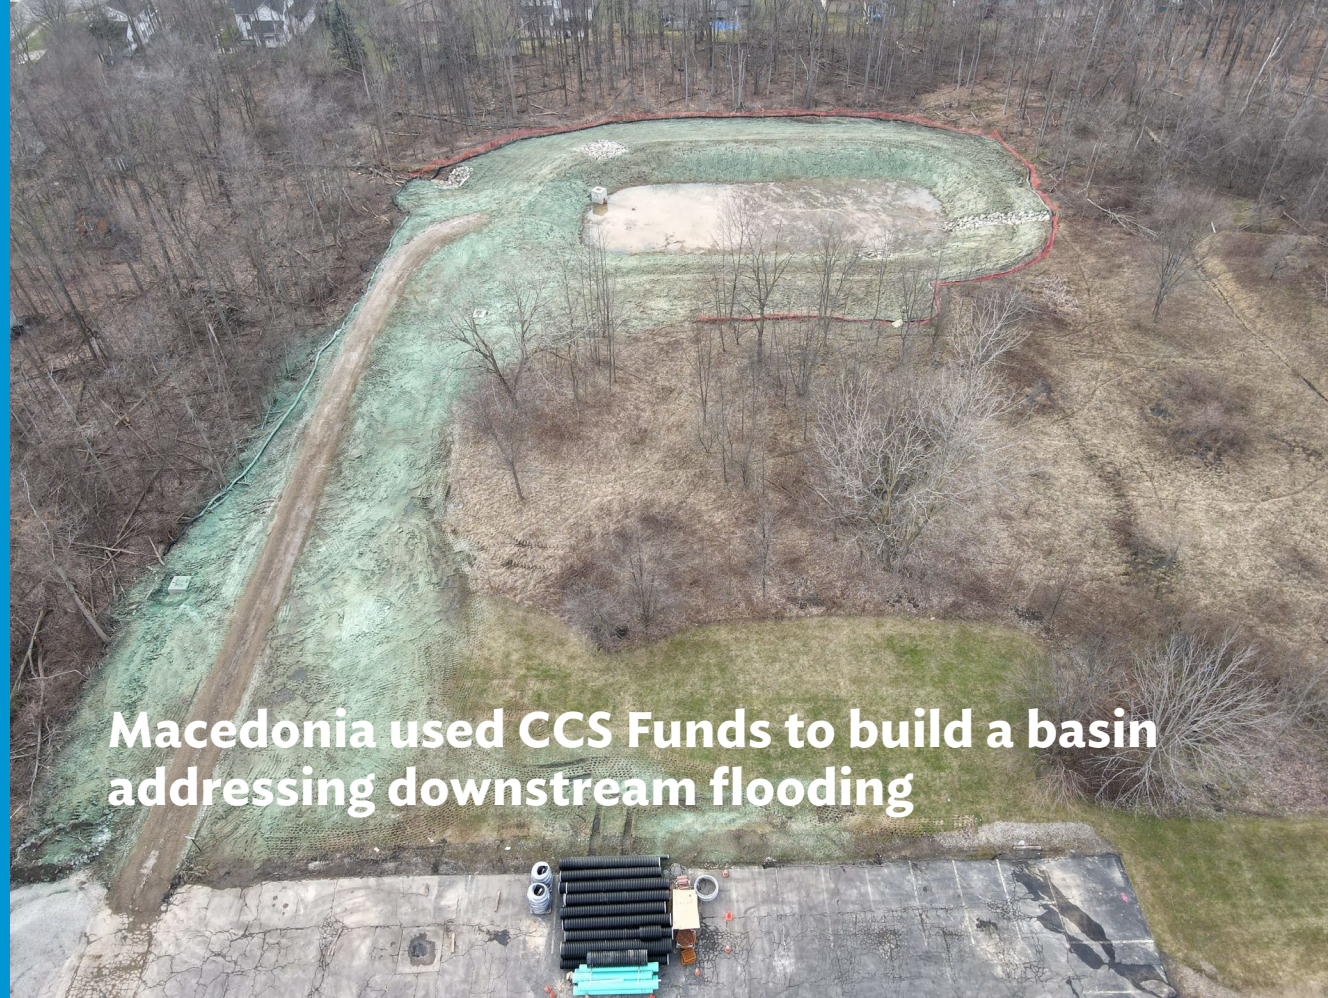
**Macedonia used CCS Funds to build a basin  
addressing downstream flooding**
