Doan Brook Enhancement Project

Conceptual Design and Implementation Schedule

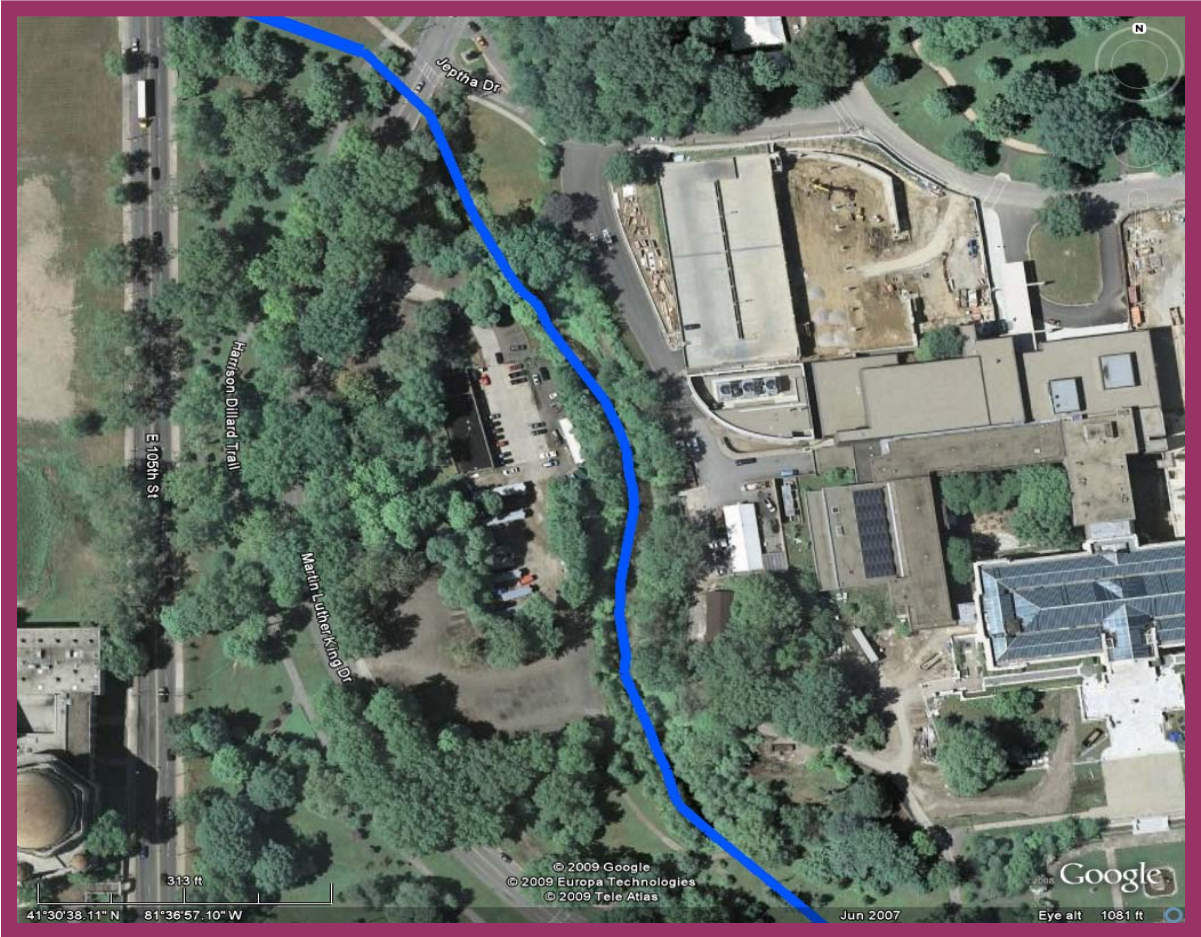
Reach 1 Overview ▶

A small section of the brook just downstream of the UC culvert has been restored and appears to be stable. Downstream, the channel has over widened and has very limited natural stream and habitat features, such as a stable pool and riffle complex. A steep bank along the east side is eroding. Sections of contributing walls remain that are in relatively good condition and the remaining banks are in fair condition.

The primary goals for Reach 1 will be to reconstruct a stable stream channel with the proper dimension, pattern, and profile that can handle the flows from the UC culvert.

It appears that the previously restored section has identified a stable cross section they could potentially be carried downstream. The steep slope behind the Museum of Art will need to be stabilized and re-vegetated. It appears that the new channel and some floodplain relief can be confined within the contributing rock walls that are still intact downstream. Stable pools and riffles, as well as native vegetation along the riparian area should provide suitable habitat for an improved biotic community.

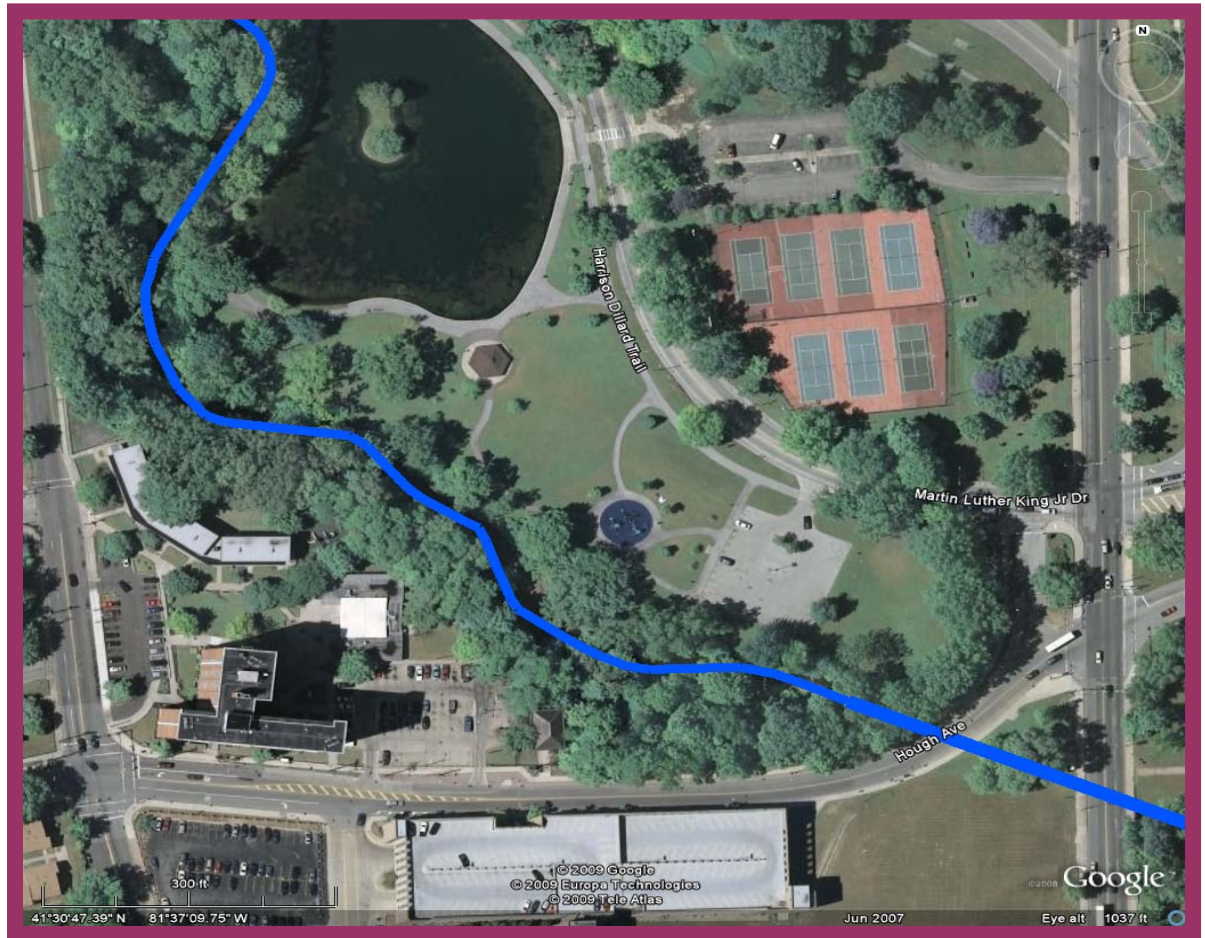
Reach 2 Overview ►

The section immediately downstream of the East 105th Street culvert is bound by a sheet pile wall that serves as the right bank for approximately 100'. Downstream, the channel has over-widened and has very limited natural stream and habitat features, such as a stable pool and riffle complex. A steep bank along the west is eroding. Most of the contributing walls through this reach are either completely missing, are severely degraded, or have been replaced with poured concrete.

The sheet pile section just downstream of the E. 105th Street culvert is doing a good job holding the bank together and probably should be left in place. The steep slope just downstream will need to be stabilized and re-vegetated.

Once the meander pattern through this reach is redesigned, there should be some thought into allowing the stream flows to access some portions of Rockefeller Park, where flood flows might minimize disruption to park users. Stable pools and riffles, as well as native vegetation along the riparian area should provide suitable habitat for an improved biotic community. There is also a section through this reach where access down to the stream should be built into the design.

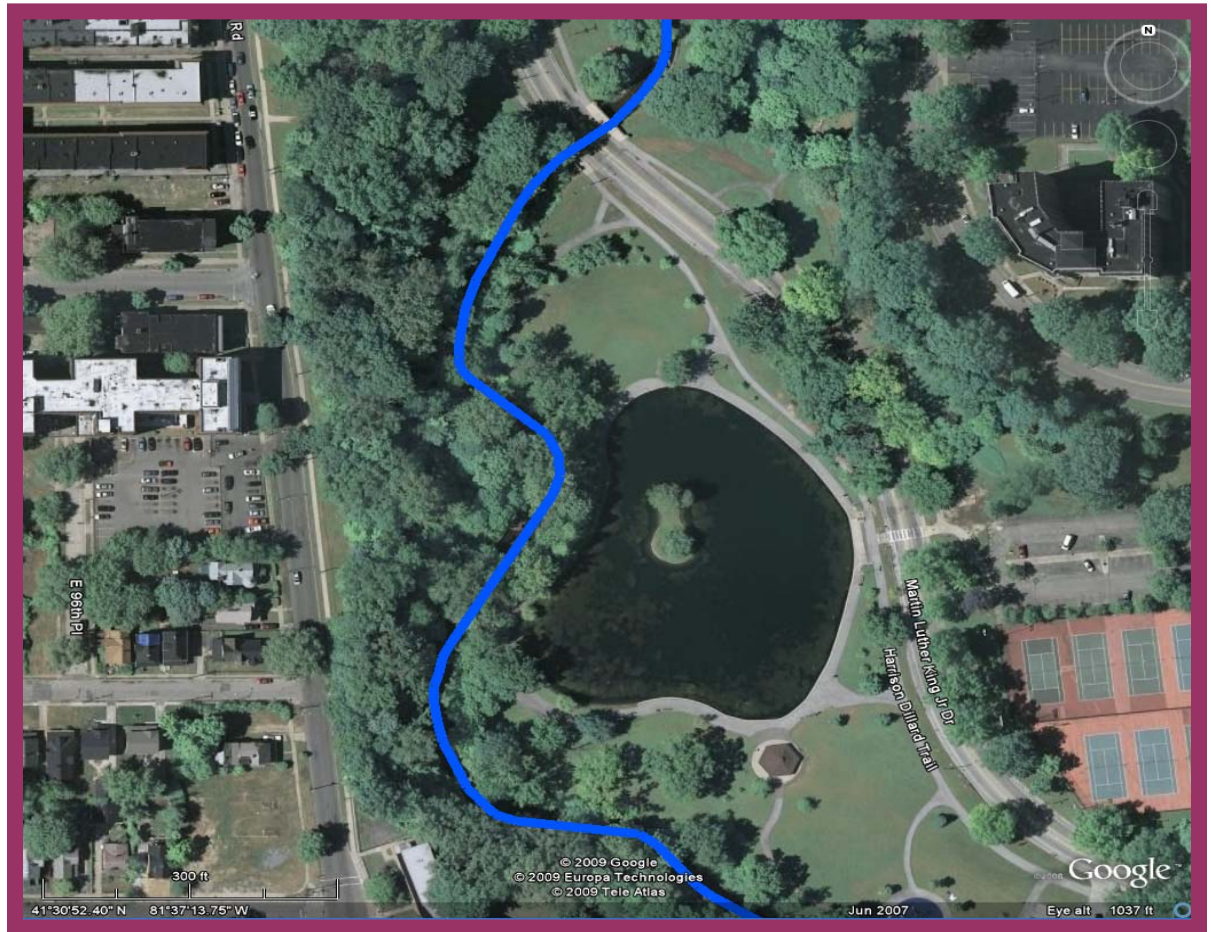
Reach 3 Overview ▶

There are remnants of a failed restoration project through this reach.

The channel has over-widened and has very limited natural stream and habitat features, such as a stable pool and riffle complex.

Most of the contributing walls through this reach are either completely missing, are severely degraded, or have been replaced with poured concrete.

The primary goals for Reach 3 will be to reconstruct a stable stream channel with the proper dimension, pattern, and profile that can handle the flows from the E. 105th Street culvert. The steep slope along the west bank will need to be stabilized and re-vegetated.

Sections of contributing walls that are still in good shape could potentially be left in place on outside meanders to provide bank stability.

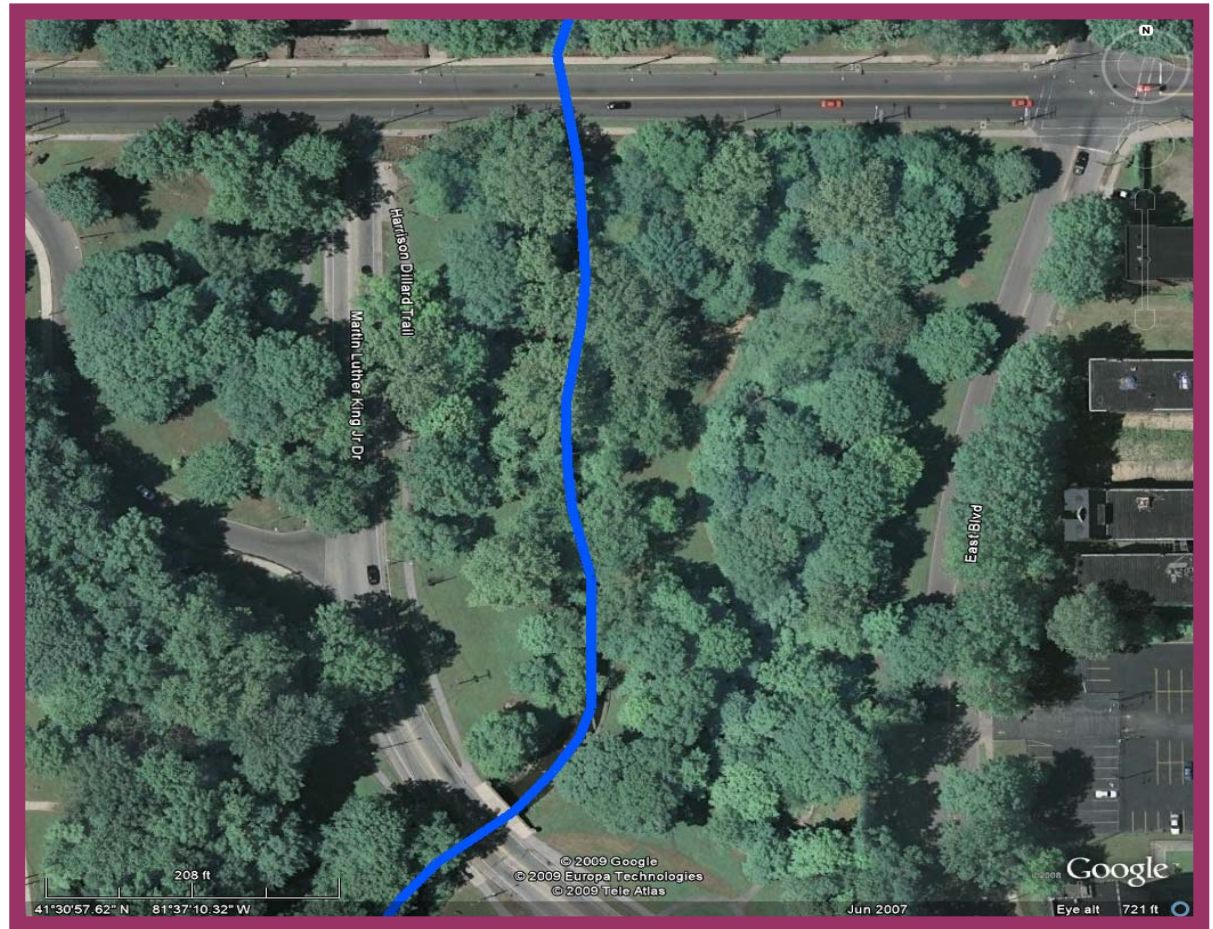
Reach 4 Overview ►

Reach 4 begins at the downstream end of the MLK Boulevard culvert and ends at the upstream end of the Wade park Boulevard culvert. This reach is approximately 550' and is the first reach within the project area where most of the contributing walls are in good condition.

There is a small section of wall that is missing just downstream of the MLK Boulevard culvert.

The channel bottom is very flat through this reach and provides very little variability in aquatic habitat.

During the assessment phase of this restoration project, the idea of building habitat between the contributing stone walls was discussed for portions of Doan Brook. This section would be a good site for keeping the contributing walls in place, up to bankfull elevation, and reconstructing the walls further back on the banks to create a wider floodplain bench.

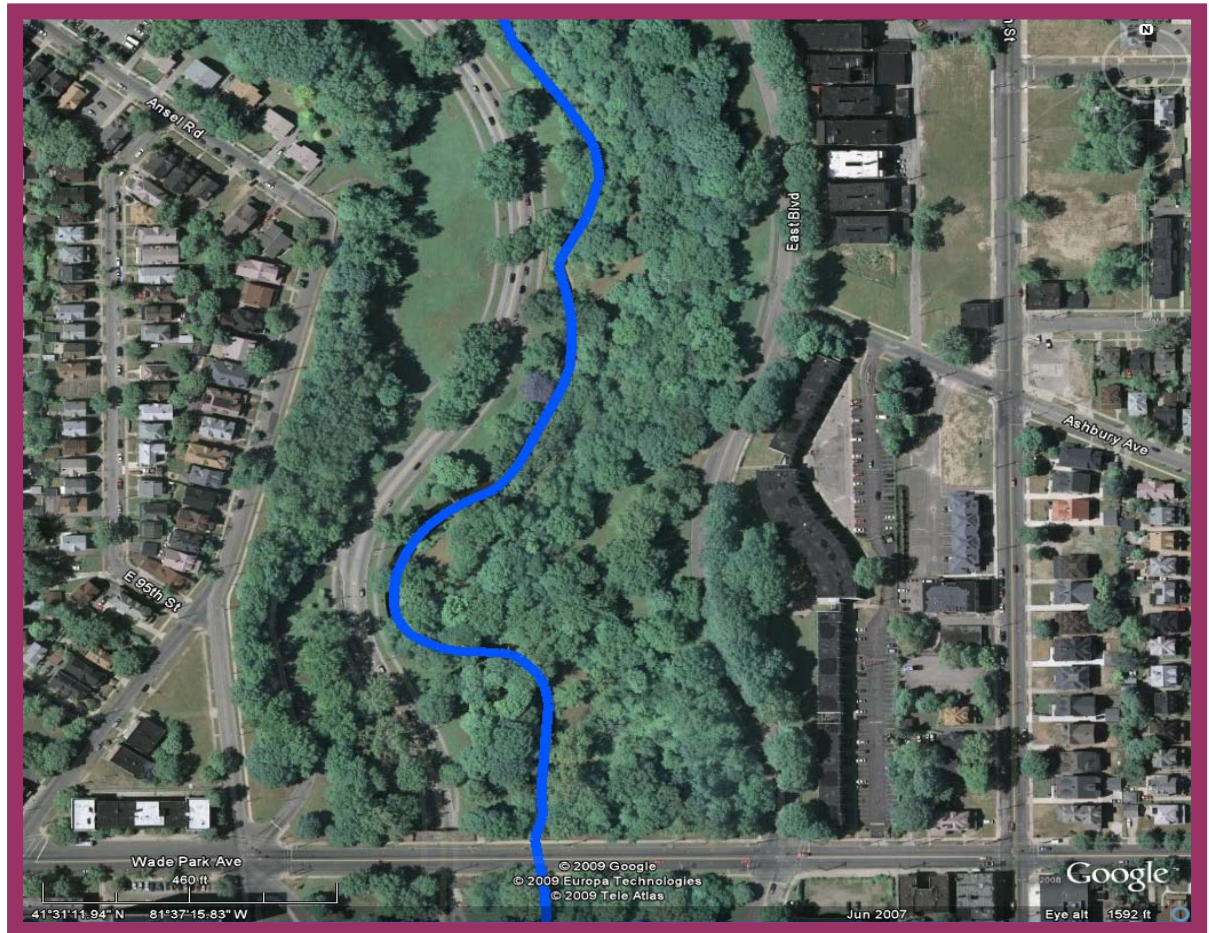
Reach 5 Overview ▶

Some of the contributing walls through this reach are severely degraded, but there are still sections that are in good condition.

The large meander bend at the start of the project area is very close to the all purpose path running along MLK Boulevard.

The channel at the end of the reach narrows considerably as it approaches the old bridge abutment.

There is room along the large meander bend to pull back the stream to the east and create a vegetated point bar. There is a small section of contributing wall through this meander that will need to be repaired, but the wall might be able to be left in place to provide bank stability and protection to MLK Boulevard. A pool / riffle system or "B" Type channel might be suitable for this reach, which might be a more natural replacement for the check dams.
